# Chip Errata for the i.MX23

This document details all known silicon errata for the i.MX23. [Table 1](#) provides a revision history for this document.

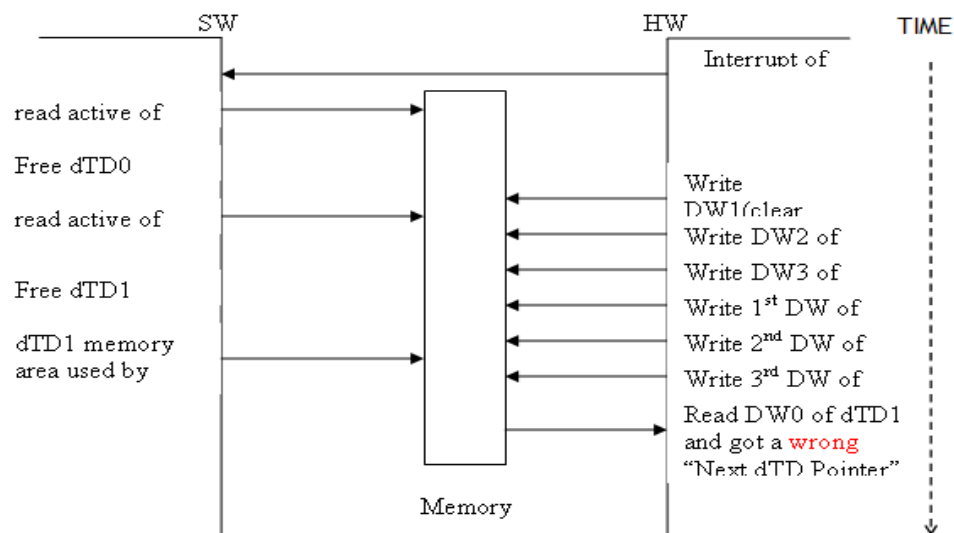
Figure 1. dTD Issue Sequence of Events

After step 1, if software finds the Active bit is cleared, then the dTD memory space is freed and this space may be allocated for other thread use. In step 3, hardware may get a wrong dTD.

This issue only occurs in USB INCR8 mode, because steps 1 and 2 have 6 SINGLE AHB transfers in INC8 mode, but only 2 burst AHB transfers in INCR mode.

This issue only occurs when the dTD list is used, because if only one dTD is used, the software only checks the Active bit after an interrupt is received (step 3). But when the dTD list is used, the software may check the entire list after the interrupt for the first dTD is received, and hardware just finished the transfer of the second dTD at this time.

The [Figure 1](#) illustrates this issue:

Postpone freeing the current dTD; free it when its next dTD can be freed, so the last completed dTD (followed by an ACTIVE dTD) is always freed when the next IOC irq comes.
